## **Utilising a unique method to monitor Large Oil Storage Tanks' deformations via Interferometric Synthetic Aperture Radar (InSAR)**

A method for monitoring the deformation of big oil storage tanks is proposed in this study. The method makes use of the Interferometric Synthetic Aperture Radar (InSAR) methodology. The purpose of this endeavour is to propose a solution that addresses the problem of oil spillage that occurs as a result of collapse of oil storage tanks. If massive oil storage tanks were to fail, it might have catastrophic consequences, including the loss of lives and property, the contamination of aquatic life, and the filing of lawsuits, among other things. Thus, the focus was on Forcados, Warri, Delta State, Nigeria as the location of the research area. The satellite imagery that were utilised were obtained from the Sentinel-1 Synthetic Aperture Radar (SAR) satellite hub of the European Space Agency (ESA) between 12-months period, covering the months of March 2017 until March 2016. In order to determine the state of these engineering structures and to identify any significant deviations from their original design, it is pertinent to perform periodic monitoring of

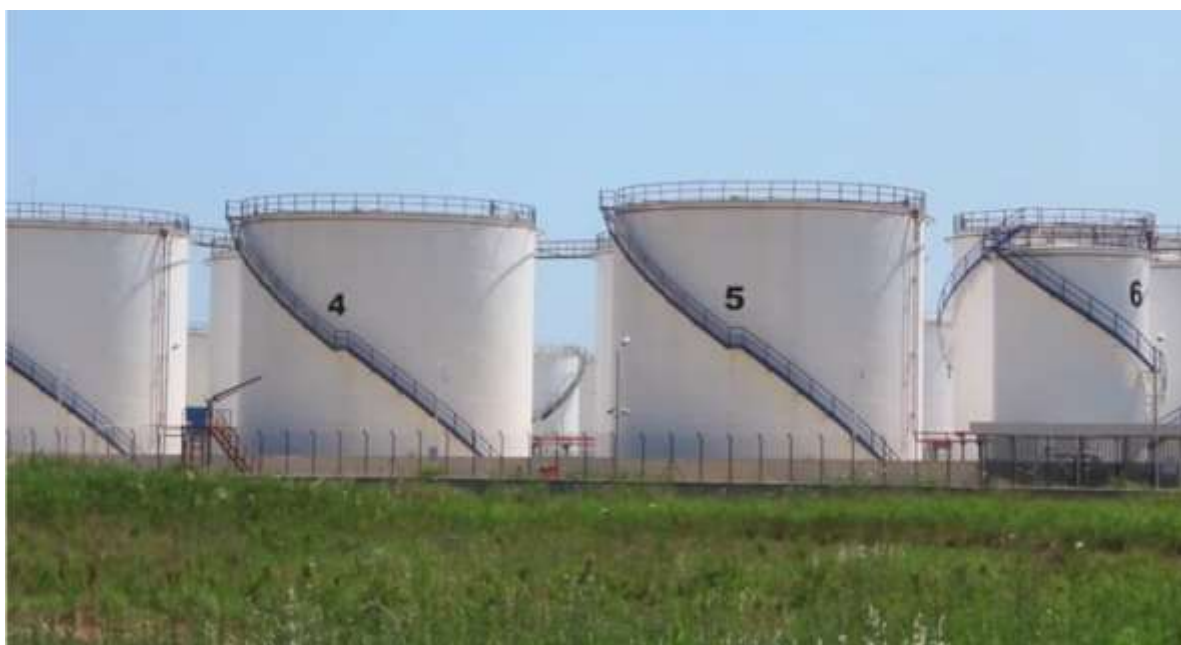
Figure 1: Cylindrical Oil storage tanks in Mosimi Depot in Ogun State, Nigeria holding four oil products. Source: [8,9]

However, oil tanks can also be positioned in an array for storage of oil, such as the Mosimi depot in Ogun State of Nigeria that was constructed in 1978 and recommissioned in 2016 by Nigerian National Petroleum Corporation (NNPC) (see Figure 1). According to NNPC, the oil tank in this depot was stated to increase Nigeria's storage capacity for petroleum products by 87.7m liters [8,9]. When they reconstructed the depot's Tanks 22, 12 and 11 back in 2016, it eased the storage capacity with a combined increased volume at 54% of the total storage capacity of petrol (also called Premium Motor Spirit-P.M.S.) [8,9]. An article by Bloomberg [10] presented a recently constructed large storage oil tanks at Dangote Refinery in Lagos, Nigeria, which is designed to

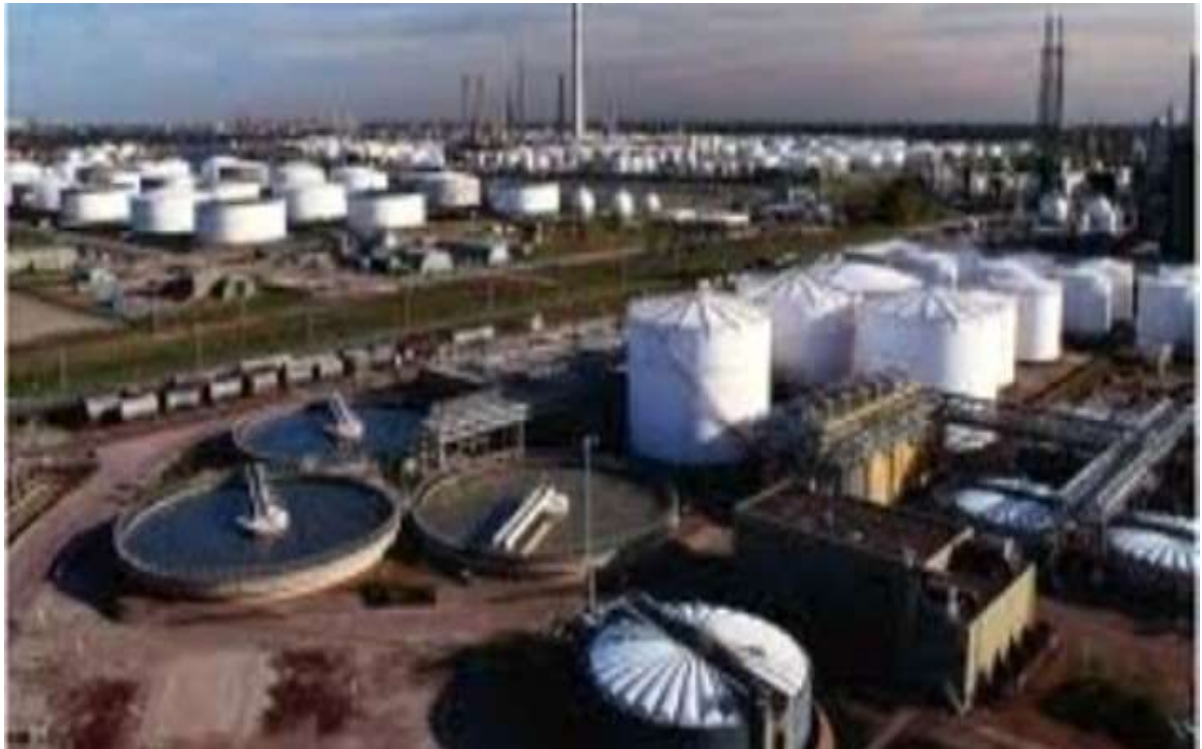
Figure 2: The Forcados Terminal in Nigeria surrounded by walls

This research was conducted by focusing on Forcados, which is located in the Warri South Local Government Area of Delta State, Nigeria. It was considered as the locality that is being investigated because it holds a resourceful oil terminal (see Figure 2). The coordinates for its location are as follows: latitude 5° 20' 01"N, longitude 5° 21' 30"E, and atitude 5° 20' 56"N, longitude 5° 20' 32"E. Ajidubu, Jala, Madagho, Ogidigben, as well as Ugborodu, are some of the communities that are located approximately 120 kilometres to the south-east of this location [7]. As a consequence of the fact that Forcados is one of the most significant petroleum provinces in the world, the geographic region has been the subject of much research (see Figure 3). Shell and Chevron, two of the most prominent multinational corporations, have their headquarters there. Operationally, Ogidigben, Otumara, as well as Sagara, are the names of the flow stations that Shell operates in Escravos. Chevron, on the other hand, establishes its flow station offshore [7]. Strong wave activity alongside tidal currents are two characteristics that can be found in the Escravos River and its surrounding area. On the beach ridge, there is a significant amount of soil formation and plant growth. There are clear challenges involved in determining the path of the pipeline due to the presence of mangrove marshy swamps and creeks that cross each other numerous times. Also, the Forcados River makes connections between the Warri River and the Burutu Channel as well as other settlements along the tributaries plus terrains as seen in Figure 3.

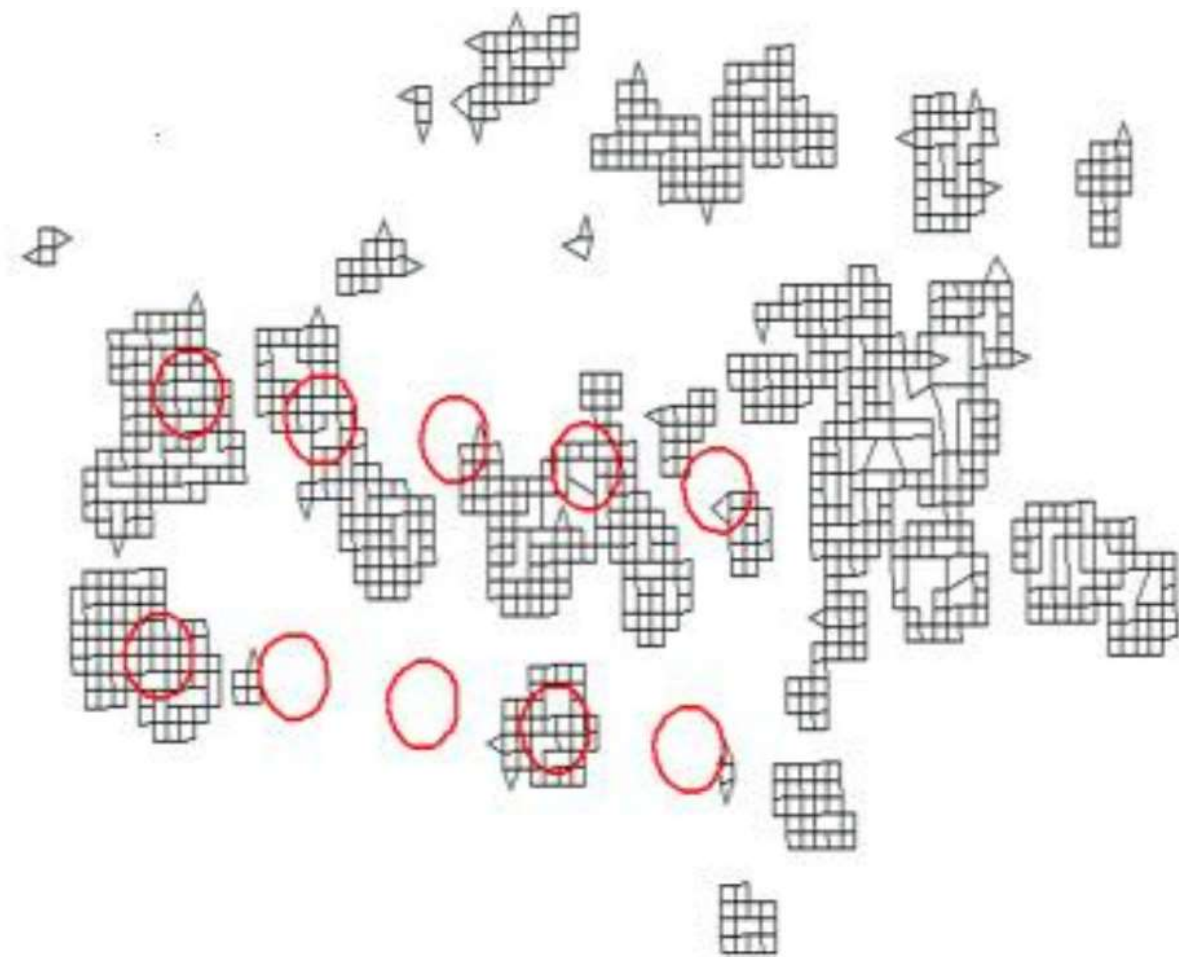
Figure 13: A segmented deformation image of crude oil storage tanks is superimposed on top of a shapefile.

In GEOBIA, where features are retrieved with respect to their numerous qualities in order to differentiate one region from another, image segmentation plays a significant role in the process. In our approach, the results of the deformation map were partitioned into raster objects, also known as segments, by employing a region expanding segmentation technique as a post classification procedure (see Figures 12 and 13). in order to get rid of the false positives and keep the actual positives (as in Figure 12), It was necessary to trim the segmented deformation image of the research area (Figure 13) The true positives segmented deformation image is superimposed with a shapefile of crude oil storage tanks, as seen in Figure 12. An existential analysis was performed on the theme object that was constructed as a result.
